## Nottinghamshire Minerals Local Plan Call for Sites 2017/2018

Site investigation at

### **Barton in Fabis**

Factual and interpretative report

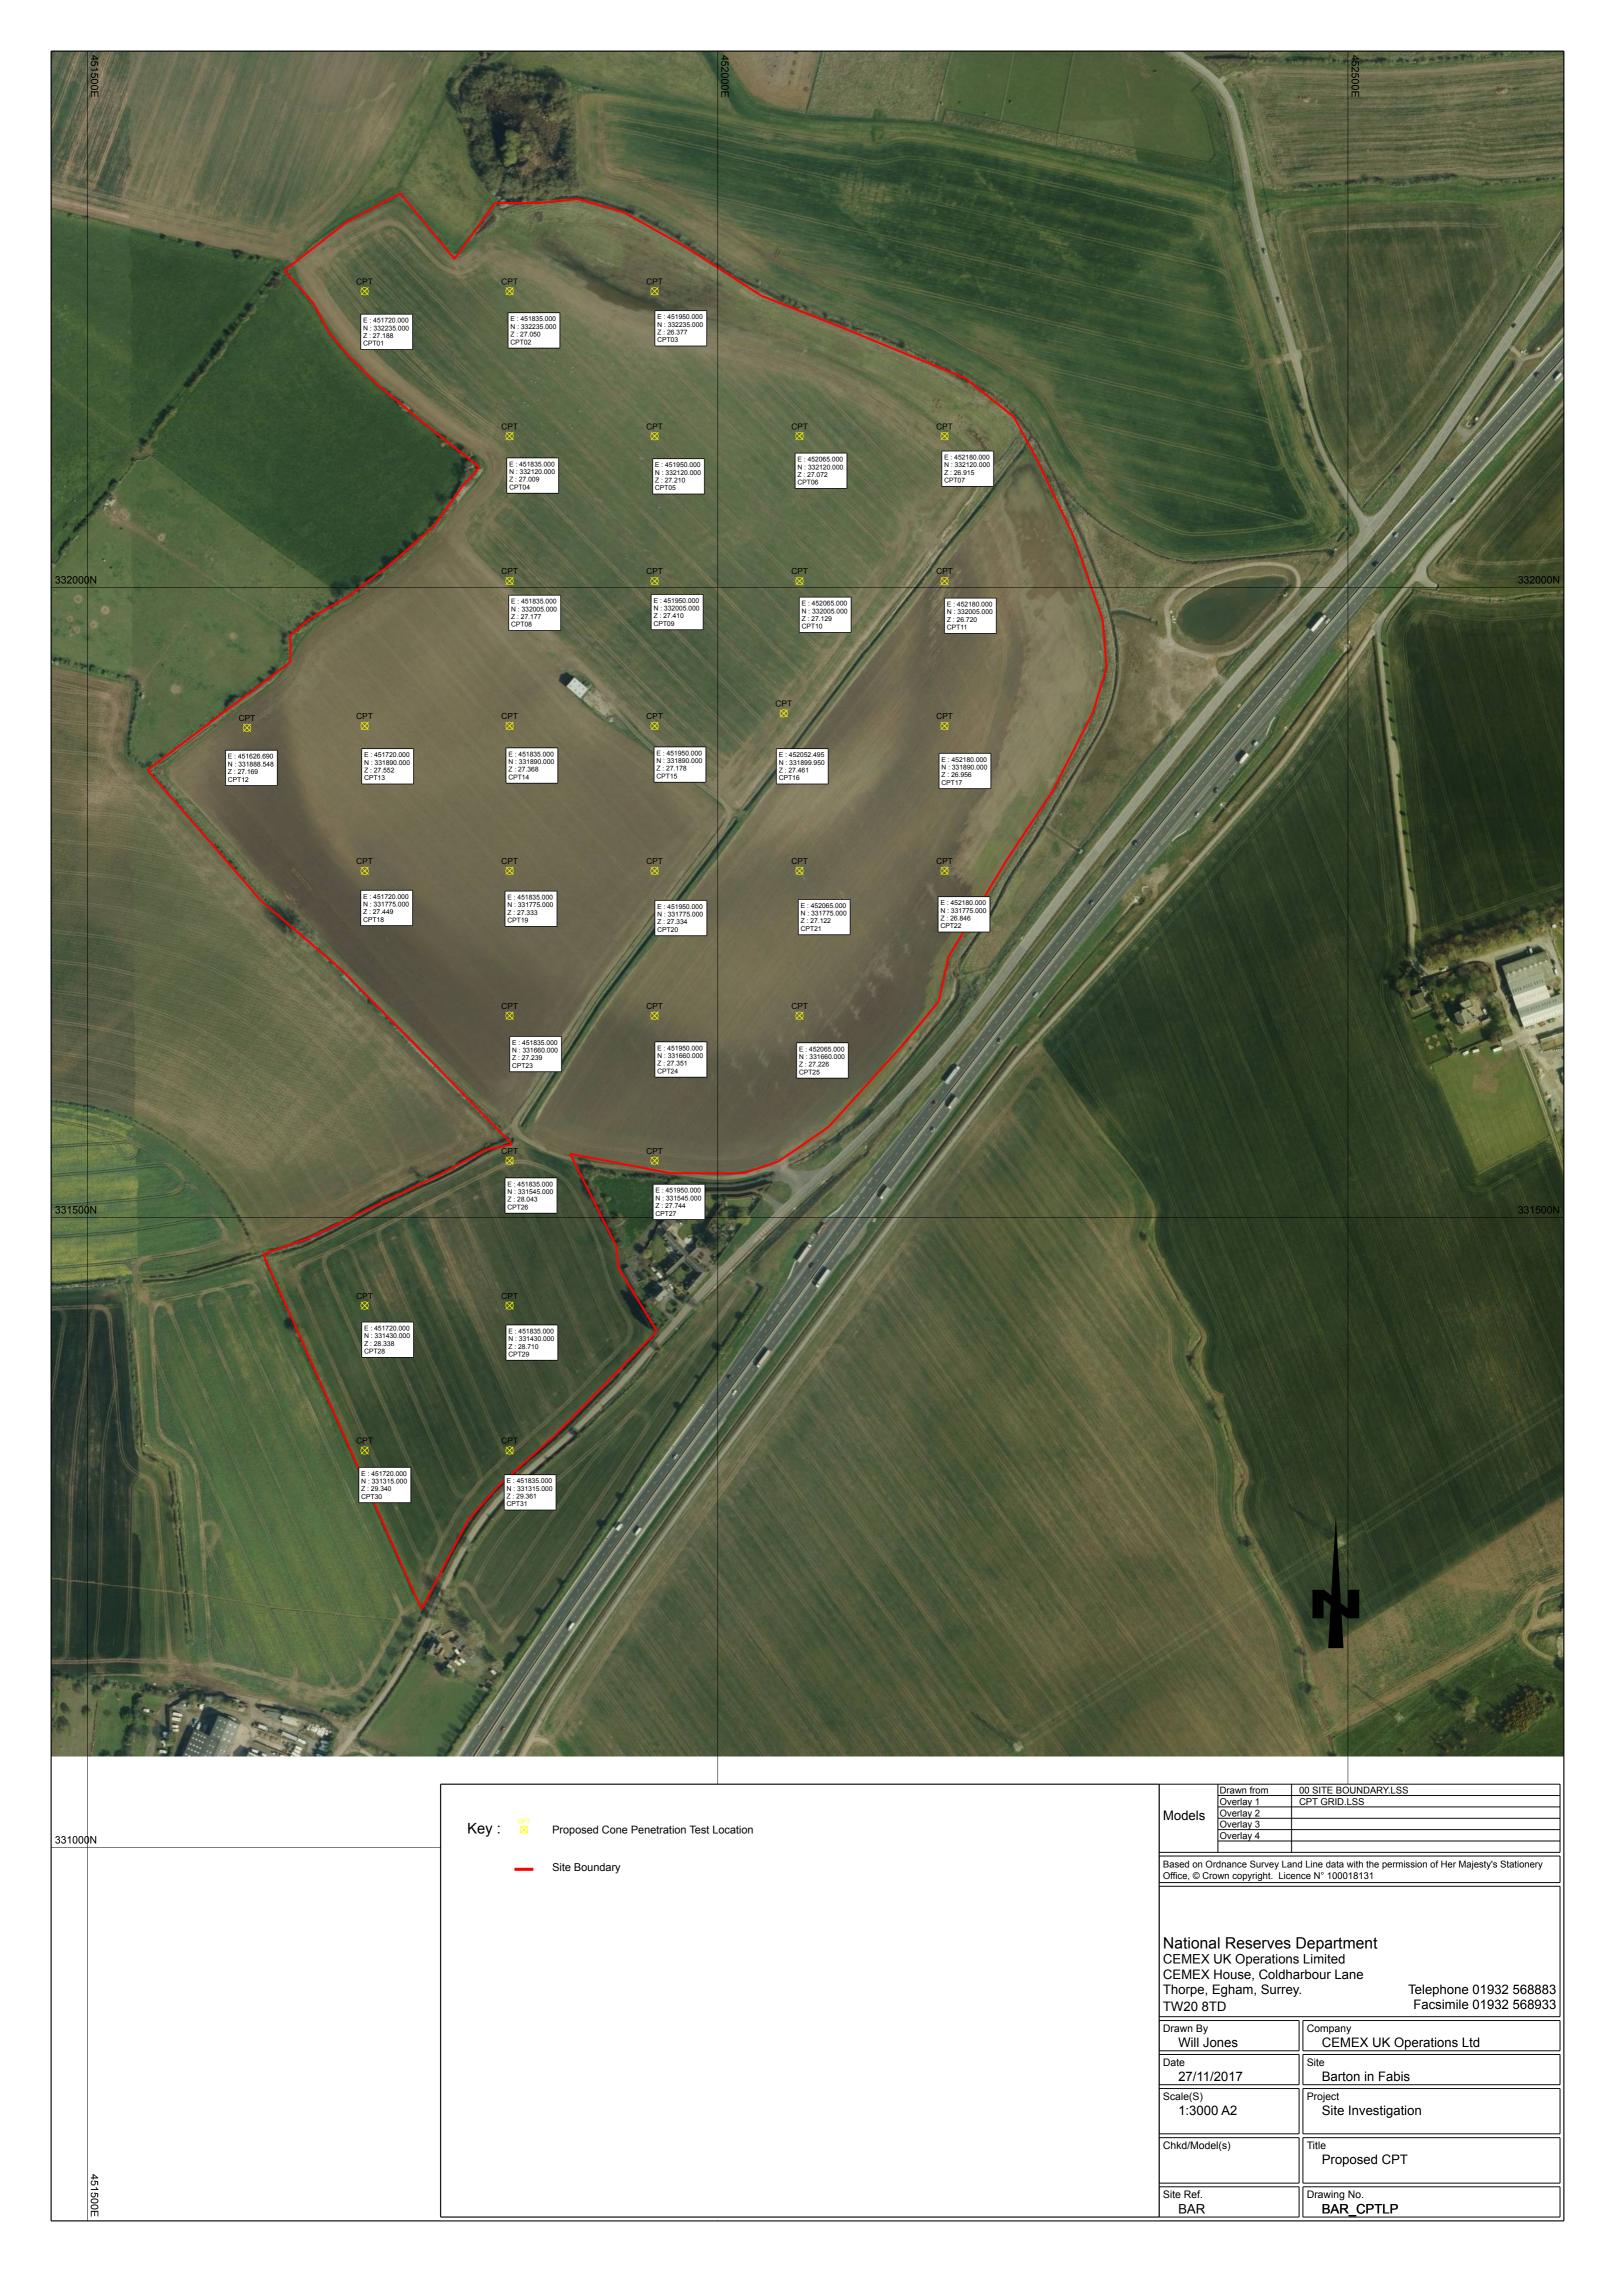
1802-W050\_BIF\_SEC\_01

Key Overburden Stripped Mineral Extracted Untouched Ground

Scale: 1:2500 (A3) Date: 12/04/2018 Drawn by: Will Jones Model: 1802-W050\_BIF\_SECS.LSS

**Cross Section**

The divisions form the basis of the cross-sections drawn through the site, which illustrate the ground conditions These sections are included in across the site. Appendix 4, along with a section location plan. They are indicative only and reference should be made to the Exploratory Hole Records for detailed descriptions of the soils and the groundwater conditions encountered. In addition to the cross sections, the exploratory hole data has been used to create contours that show the base of overburden and base of mineral. These drawings, referenced 1802-W050 BIF BOOBCON and 1802-W050\_BIF\_BOMCON are included Appendix 4. A plan of the site detailing thicknesses of overburden and mineral (referenced 1802-W050\_BIF\_BHSUM) is also contained within Appendix 4.

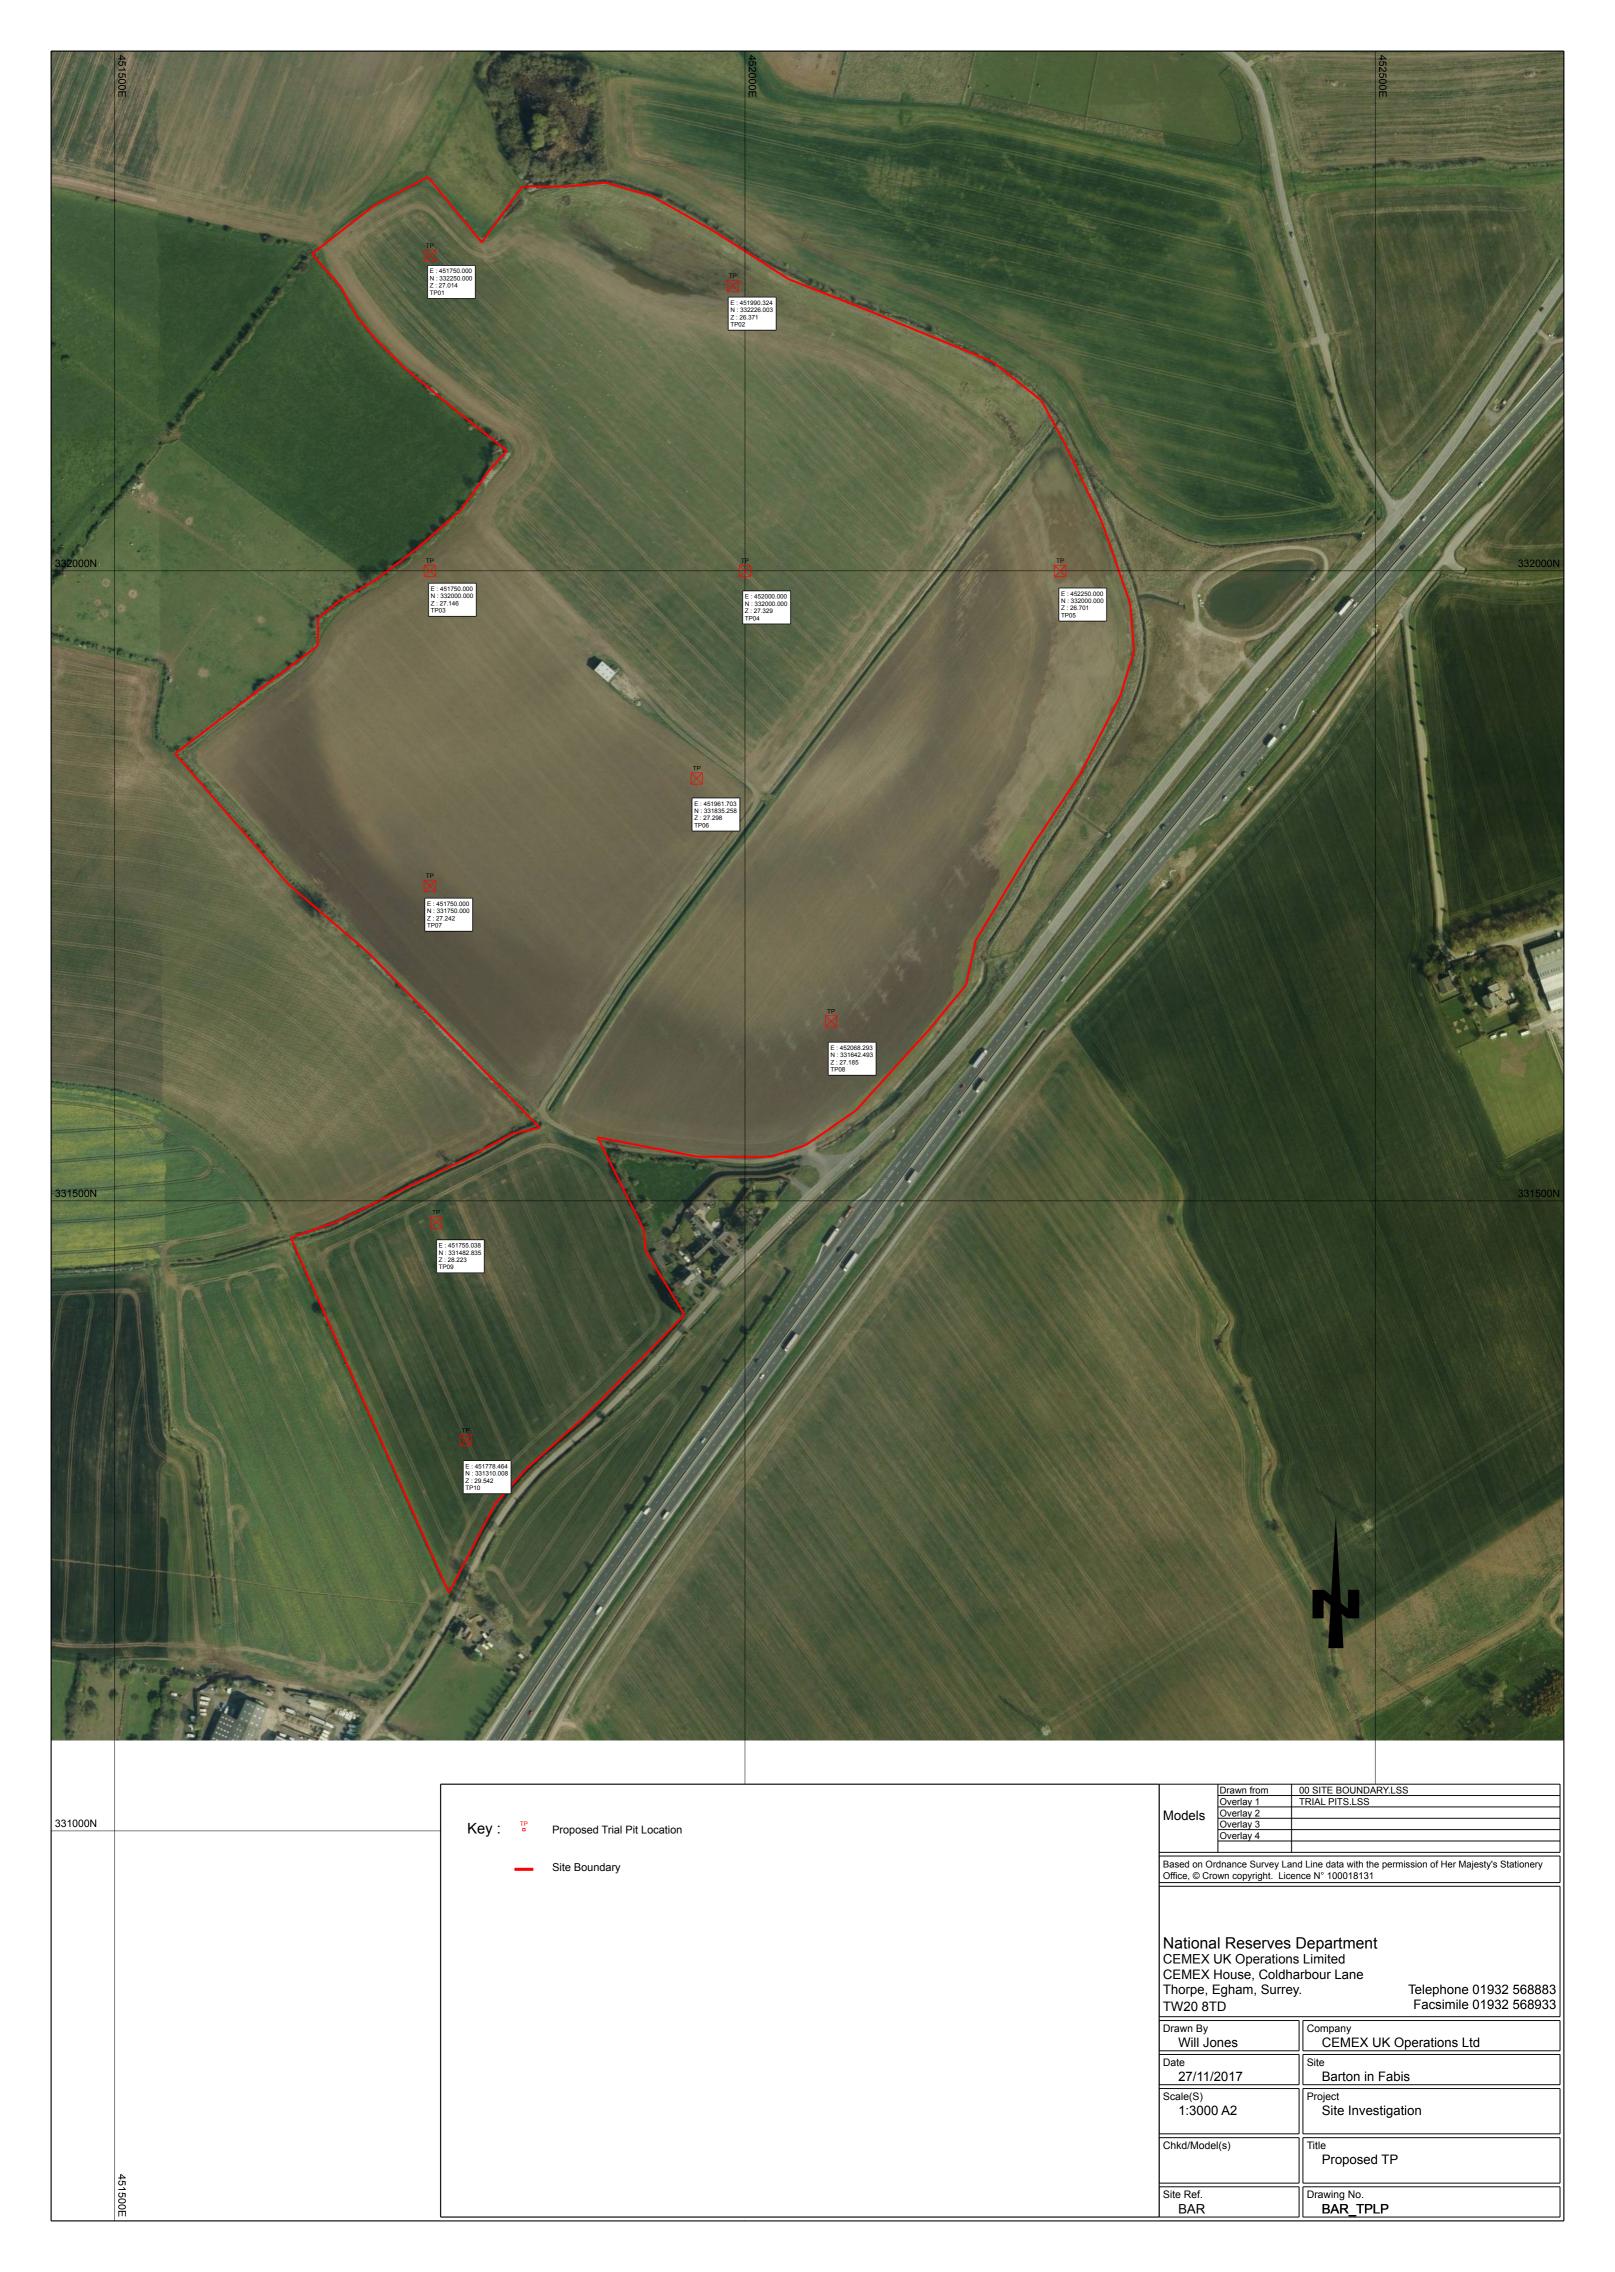
1802-W050\_BIF\_SEC\_02

Overburden Stripped

Mineral Extracted

Untouched Ground

**Cross Section**
