APPENDIX A

SECTION 19 REPORT – WORKSOP – AUGUST 2022

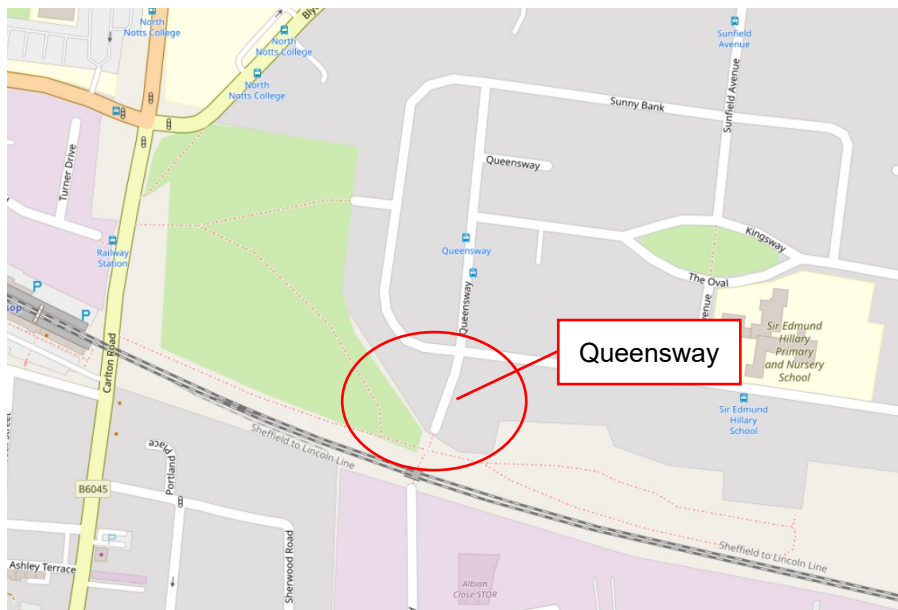
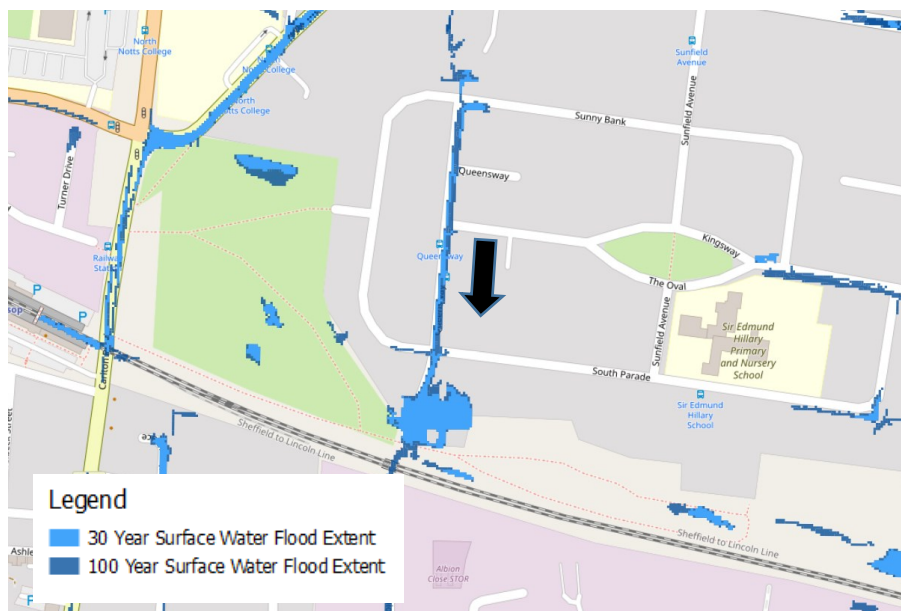
Figure 8. Location Plan – Queensway

Three residential properties internally flooded on Queensway. Water flowed from the north of the catchment to the south of Queensway where it is impounded by the higher topography of the railway line (Figures 8 and 9). This resulted in internal flooding of properties.

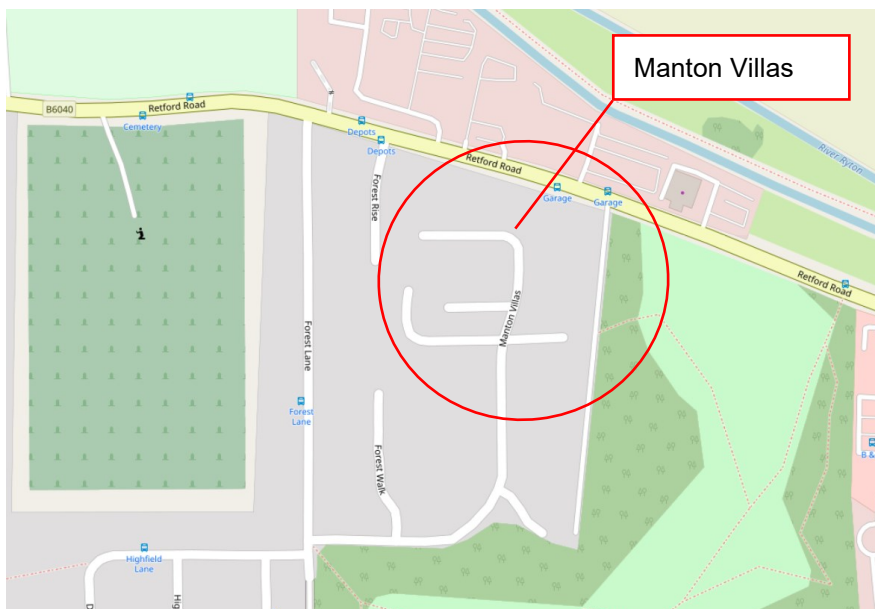
Figure 13. Location Plan - Manton Villas.

One property on Manton Villas and one business on Retford Road was internally flooded (Figure 13).

Surface water flowed down the highway of Manton Villas following the topography towards Retford Road. This flow path continued towards Retford Road and flooded a business property. Figure 14 shows that surface water flood risk mapping predicts a flow path from the south.
