APPENDIX N

SECTION 19 REPORT – WOODBOROUGH – STORM HENK - JANUARY 2024

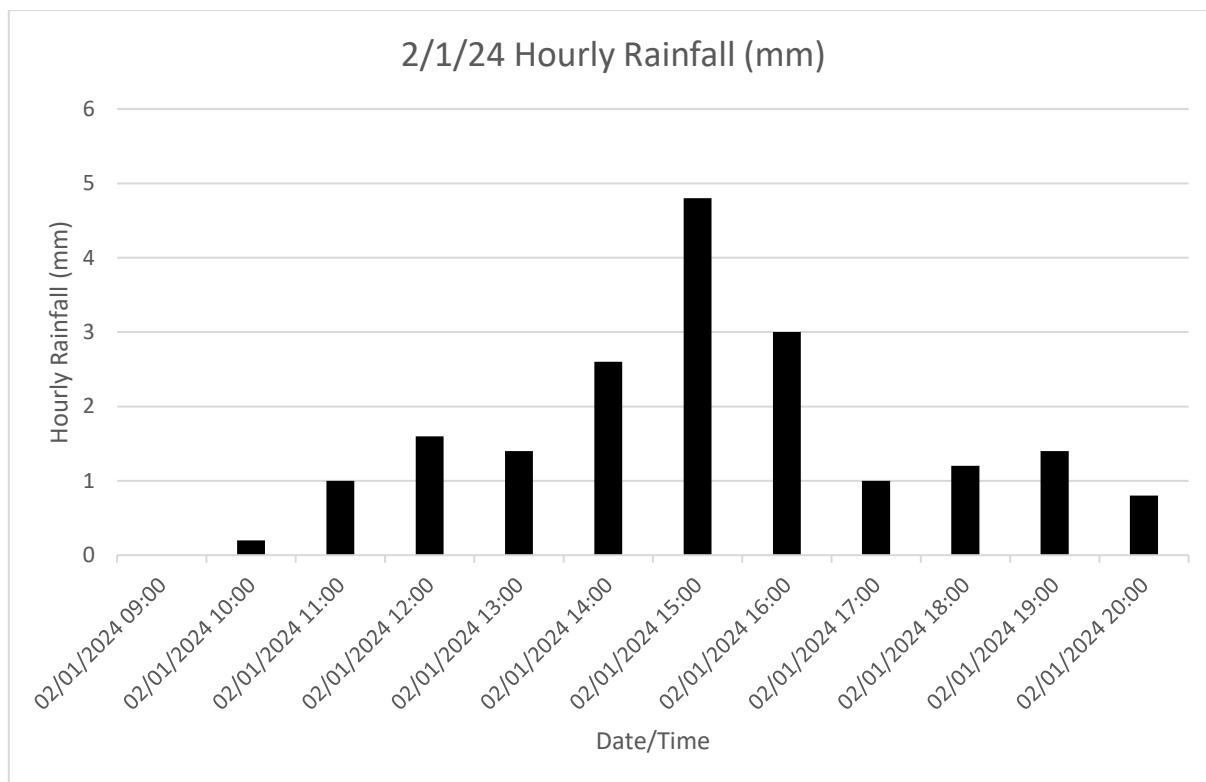
Figure 1. Calverton Hourly Rainfall 2nd January 2024. Data supplied by the Environment Agency.

8. On the 2nd of January 2024, during Storm Henk, Woodborough suffered a flood event caused by sustained rainfall over a saturated catchment. On this day, 19mm of rainfall was recorded at the Calverton rain gauge (Figure 1) with a maximum 60 minute intensity of 4.8mm/hr. A peak water level of 1.048m was recorded at the Woodborough Brook Level Gauge at 16:15. Consequently, 24 residential properties and one business were subject to internal flooding with more suffering flooding to gardens and outbuildings.
9. This storm came after a prolonged period of persistent rain and above average rainfall which had saturated the ground, resulting in flooding of roads and properties quicker than they would following a dry period.

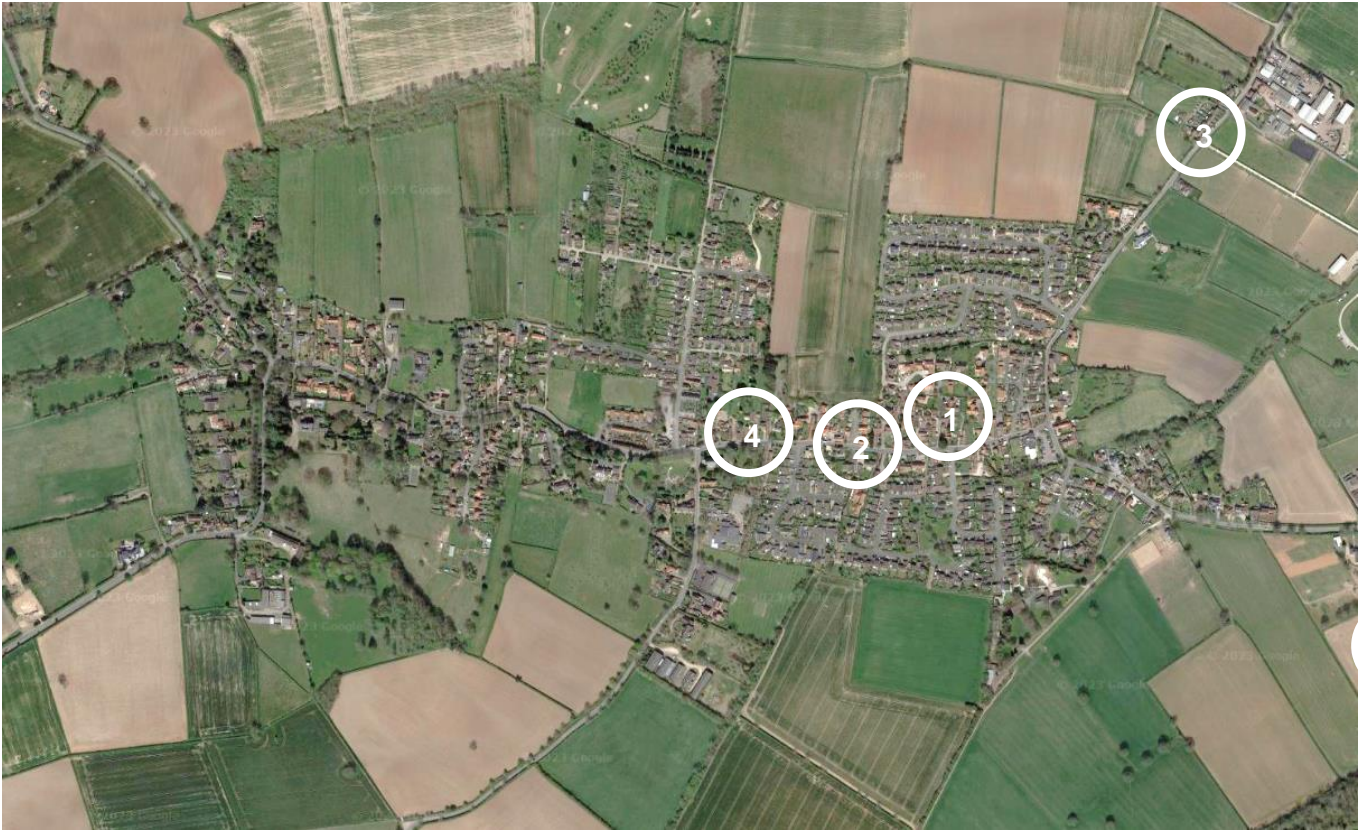
10. A location map of Woodborough is shown in Figure 2. The areas affected were:
 - Main Street (21 properties)
 - Smalls Croft (1 property)
 - Shelt Hill (2 properties)
 - Pinfold Close (1 property)

Figure 2. Reference Map for flood affected areas across Woodborough. Main Street (1), Smalls Croft (2), Shelt Hill (3), Pinfold Close (4).

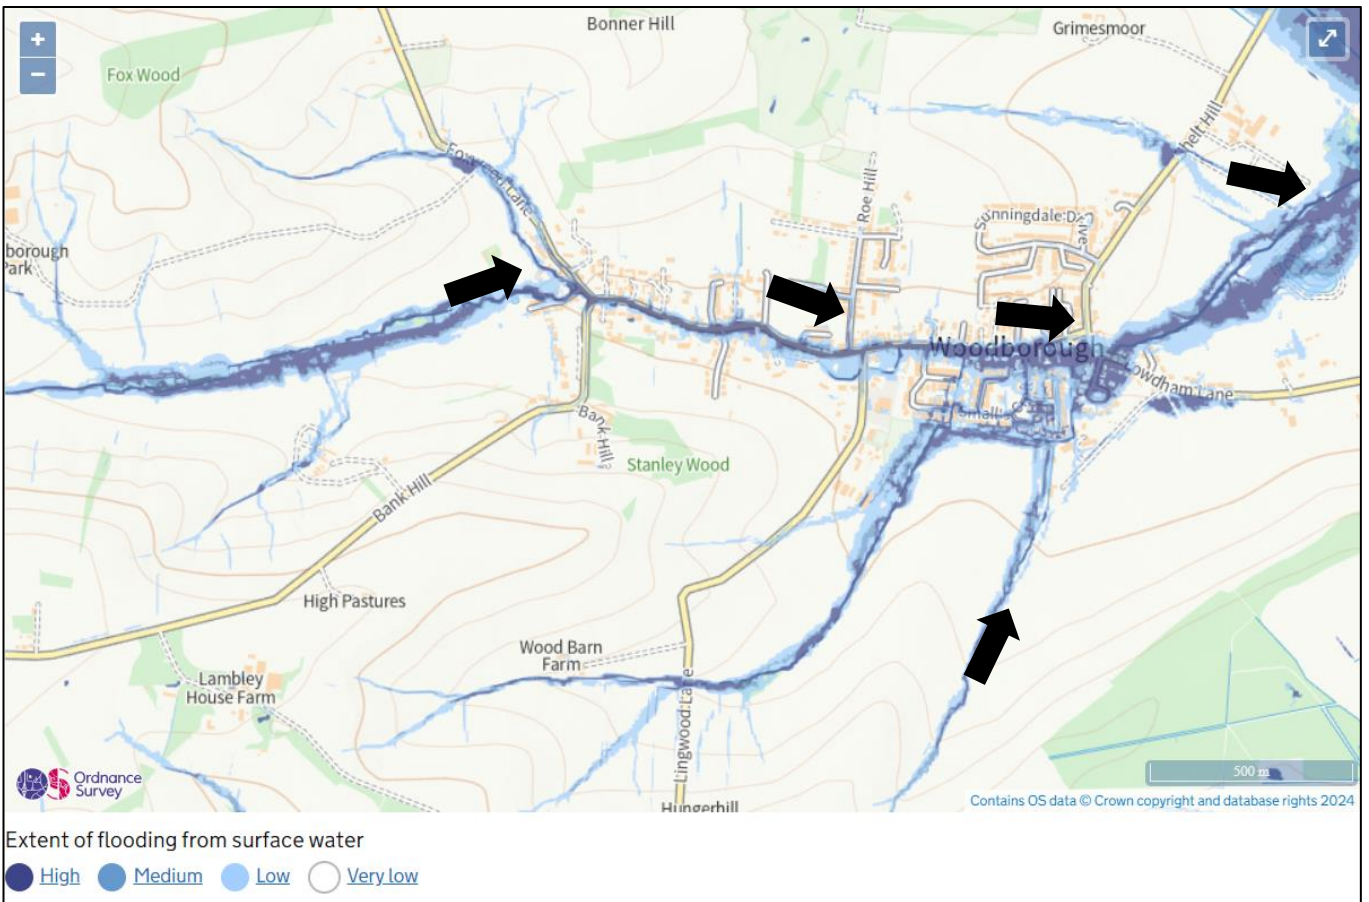
Figure 3. Surface Water Flood Risk Mapping - Woodborough. Data Supplied by Environment Agency.

13. During Storm Henk, upper catchment runoff influenced by rainfall onto an already saturated catchment caused the watercourse to rise to a level which exceeded the channel capacity. This resulted in water flowing eastward along Main Street which is shown as a surface water flow path in Figure 3. The water entered several properties as it flowed along the road. Some properties along Main Street are built at a lower elevation than the road itself. As a result, water flowing along the highway flowed through property boundaries and into some properties.

16. Two residential properties suffered internal flooding on Shelt Hill (Figure 6). A surface water flowpath is present which flows from the west of Shelt Hill to the East (Figure 3). The water is managed by a drainage ditch system in the field which then flows through a culvert under the road of Shelt Hill. Due to rainfall over a saturated catchment resulting in enhanced overland flow, the culvert was overwhelmed and water pooled on the western side of the road as the road is higher than the properties. This caused internal flooding to properties adjacent to the road.

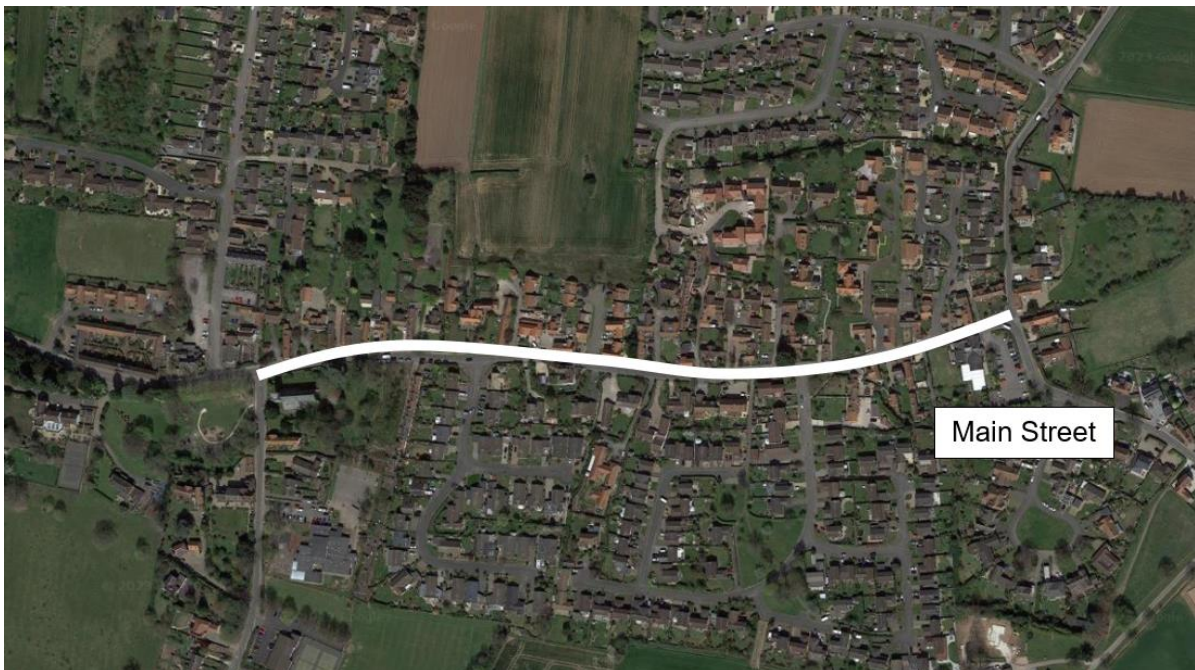
Figure 4. View of Main Street.

11. Areas impacted by flooding on Main Street are shown in Figure 4. In total, 20 residential properties and one business were impacted by flooding.
12. The Woodborough Brook flows along the south side of Main Street and is joined on Main Street by two tributaries originating from the south of the catchment.

14. The flooding along Main Street also cut off many residents in Woodborough who were unable to get out of or into the village for many hours. It should be noted that the Woodborough Flood Action Group have reported that between Storm Babet (October 2023) and Storm Henk (January 2024), water has exceeded channel capacity and flowed along Main Street multiple times which has caused severe disruption for the village.

- 29. At the time of writing, a natural flood management project is being delivered by NCC within the upper catchment of Woodborough. Delivery of the scheme will continue with an aim to create storage to temporarily attenuate water during flood events and reduce flood risk.

- 35. NCC are investigating the connectivity and condition of drainage assets in the Shelt Hill and Bank Hill areas.
- 36. The Environment Agency have carried out CCTV of the culverts and will now review the current condition of the culvert to see if any further actions need to be taken to ensure the continued conveyance of the watercourse through Woodborough.

- 37. As part of a National Programme of debris screen improvements, in East Midlands the Environment Agency is progressing outline design for 12 screen improvements over 24/25. The aim is to progress to detailed design and construction in 2025. The 3 screens in Woodborough, which are referred to as Church Yards Screen and 124 and 128 Main Street are part of our 12 screen improvements. The objective of the programme is to ensure the screens are compliant with current CIRIA guidance. The current screens perform well but operational improvements will make them safer and easier to maintain.

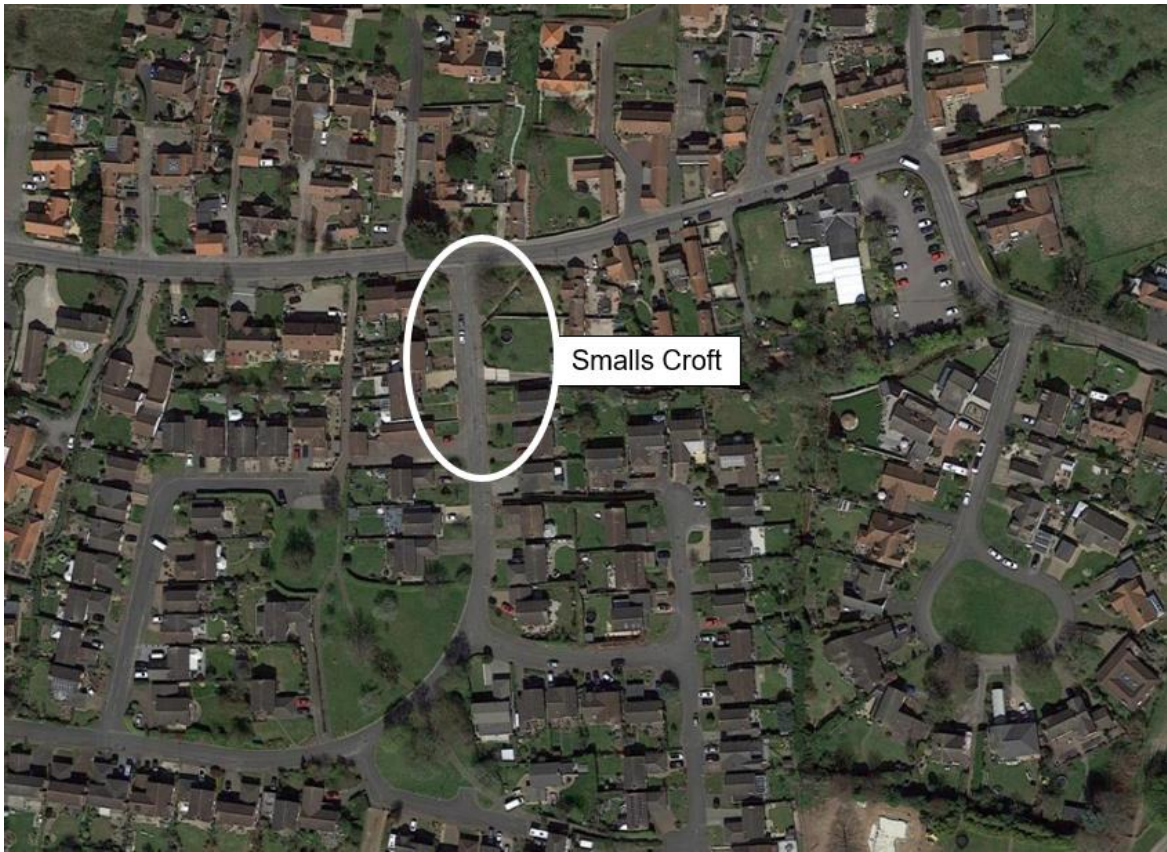
Figure 5. View of Smalls Croft.

15. On Smalls croft, 1 residential property was internally flooded by water from the Woodborough Brook which came out of bank and flowed down Main Street. A location plan is shown in Figure 5. Due to its lower topography, water pooled on Smalls Croft and internally flooded a property.

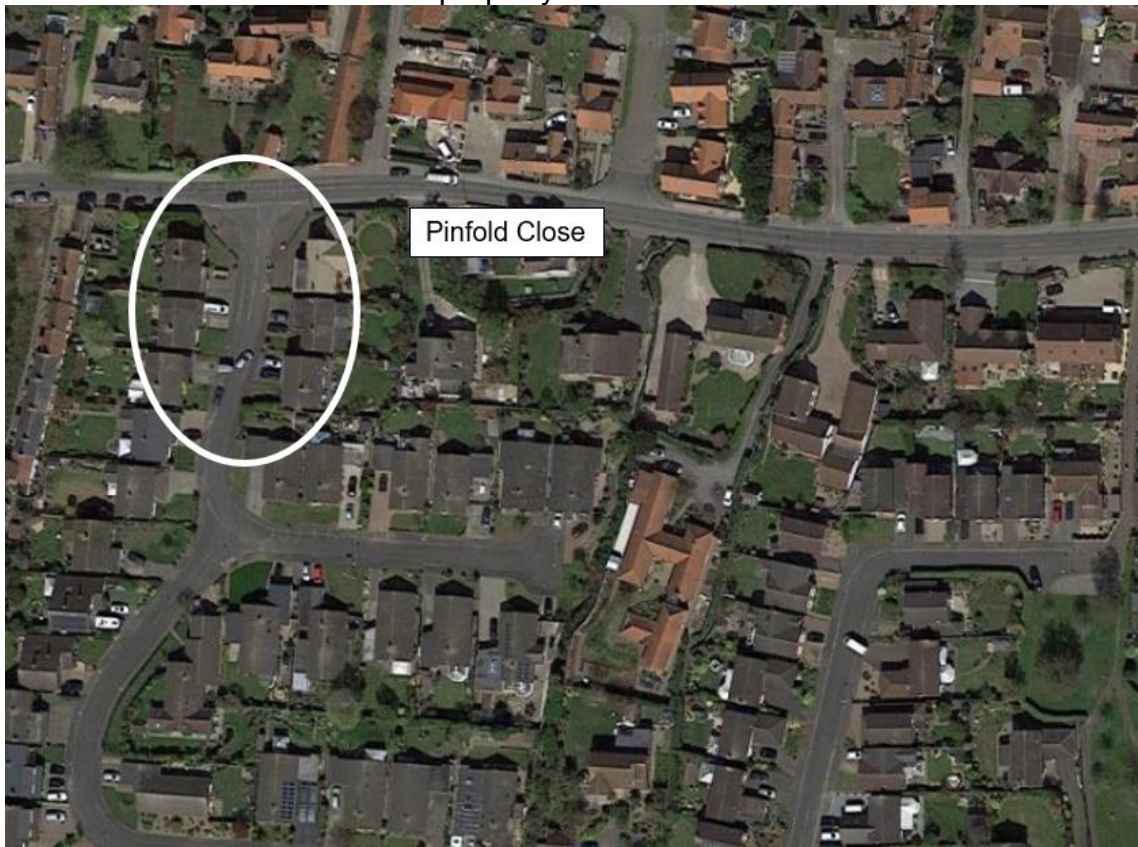
Figure 7. View of Pinfold Close.

17. On Pinfold Close, one residential property was internally flooded by water from the Woodborough Brook when the channel capacity was exceeded and water flowed down Main Street (Figure 7). Due to its lower topography, water pooled in areas of Pinfold Close which then affected the property.
