## **APPENDIX A**

### **SECTION 19 REPORT – BURTON JOYCE – STORM HENK, JANUARY 2024**

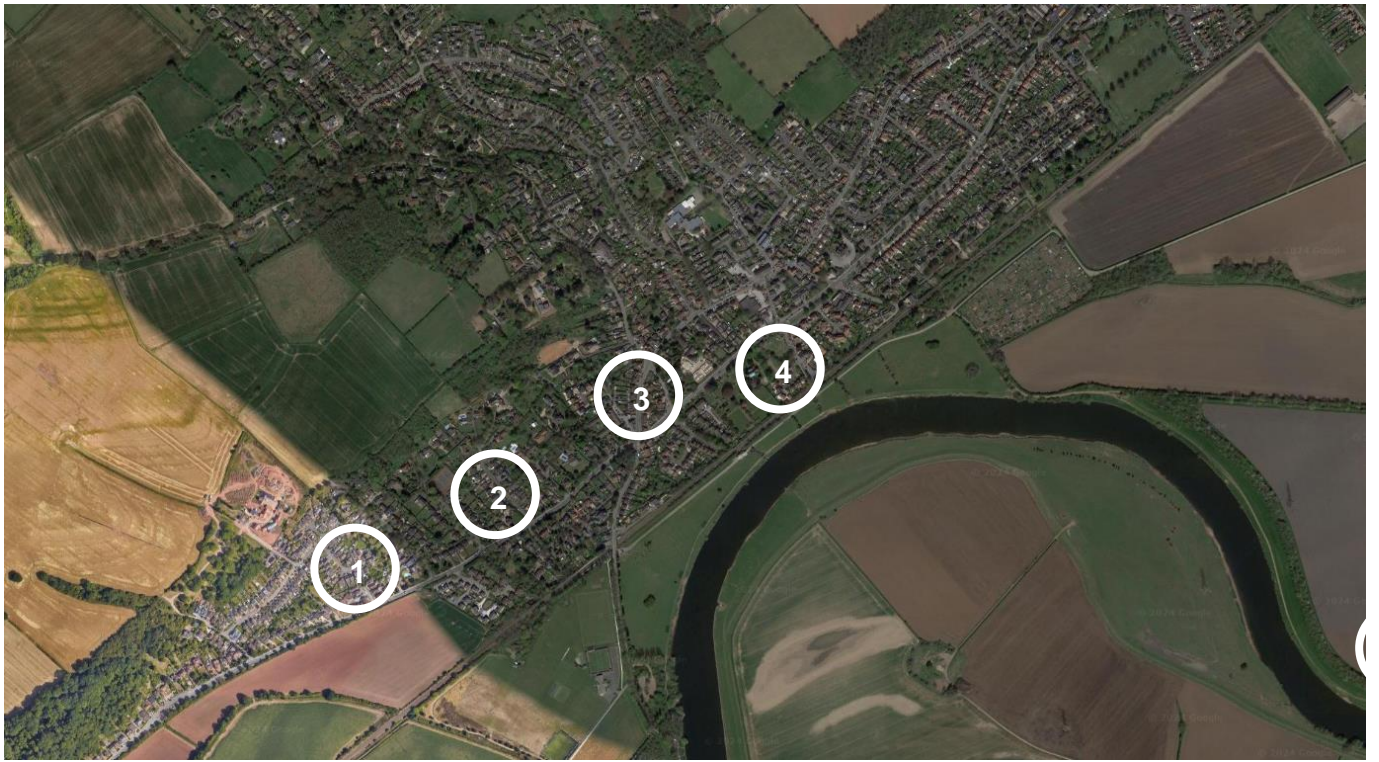
10. A location map of Burton Joyce is shown in Figure 2. The areas affected were:
  - Nottingham Road (4 properties)
  - Cragmoor Road (1 property)
  - Main Street (1 property)
  - Chestnut Grove (4 properties)

**Figure 2.** Reference Map for flood affected areas across Burton Joyce. Nottingham Road (1), Cragmoor Road (2), Main Street (3), Chestnut Grove (4).

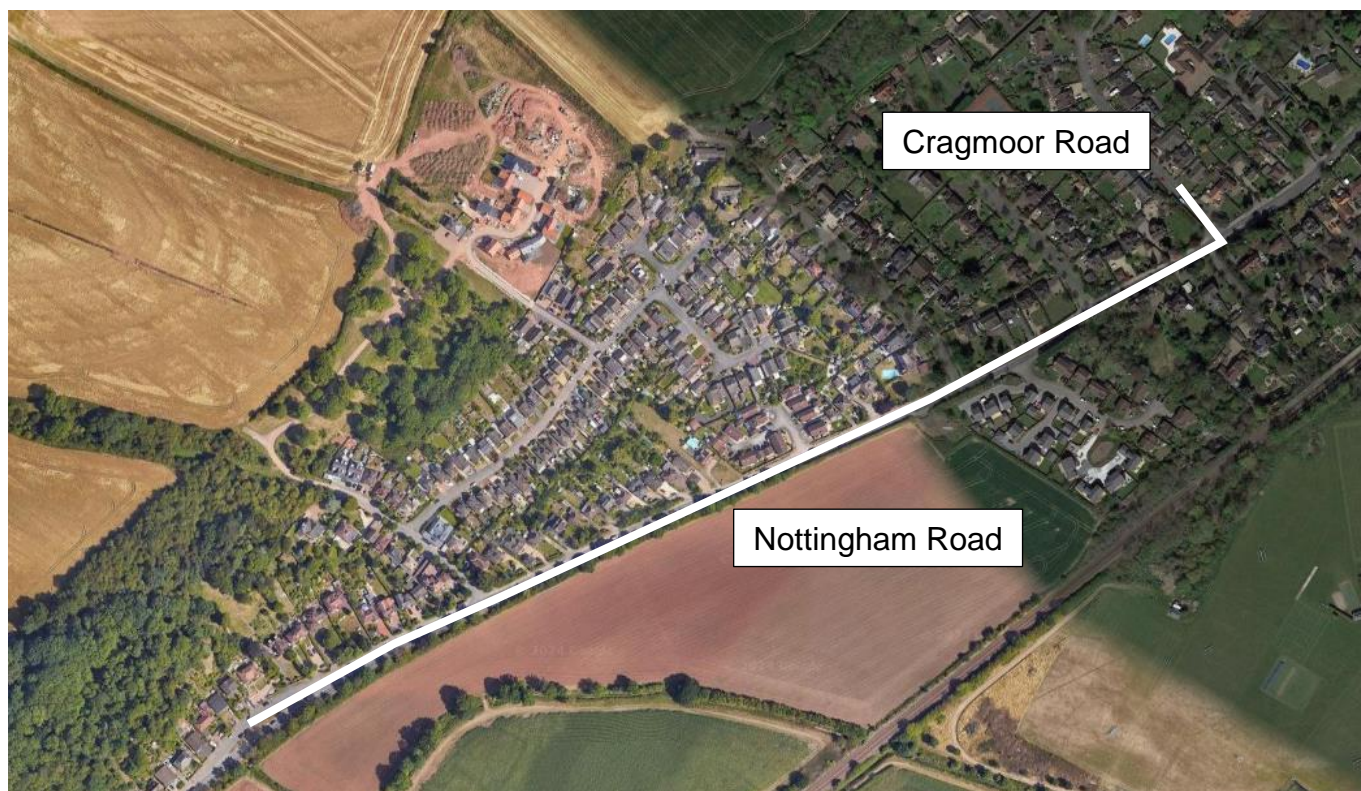
11. Areas impacted by flooding on Nottingham Road and Cragmoor Road are shown in Figure 4. In total, 4 residential properties were impacted by internal flooding on Nottingham Road with 1 impacted on Cragmoor Road. Many other properties suffered external flooding in this area during Storm Henk.

12. Three watercourses exist in this area; one flowing from the north along Whitworth Drive, another originating north of Woodside Road and a third originating from north of Crow Park Drive. These three watercourses become culverted as they enter the village, with the Woodside Road and Crow Park Drive watercourses ultimately flowing through the STW surface water sewers within the village. During Storm Henk, upper catchment runoff influenced by rainfall onto an already saturated catchment caused all three watercourses to exceed the capacity of the downstream culverts, with water then flowing along the adjacent roads/gardens. At Whitworth Drive, water flowed eastwards along Nottingham Road which caused highway flooding and consequent issues for vehicles, but was not found to directly cause internal property flooding. The watercourse originating from the north of Crow Park drive caused some external flooding locally.

13. Following the flooding, investigations by NCC and STW have found that the watercourse originating from the north of Woodside Road had an unauthorised connection into the STW combined sewer system which caused the system to surcharge onto Woodside Road and Nottingham Road. This may have contributed to the flooding on Nottingham Road and further along the combined sewer system at Cragmoor Road. It should be noted it should be noted that STW have stopped water entering the combined system through the unauthorised connection, with NCC and STW monitoring for any flooding occurrences in the area.

**Figure 4.** View of Nottingham Road and Cragmoor Road.

26. Investigations by NCC and STW on the flooding issues originating from the watercourse north of Woodside Road have been undertaken with the misconnection now resolved. NCC and STW are monitoring the flooding situation.

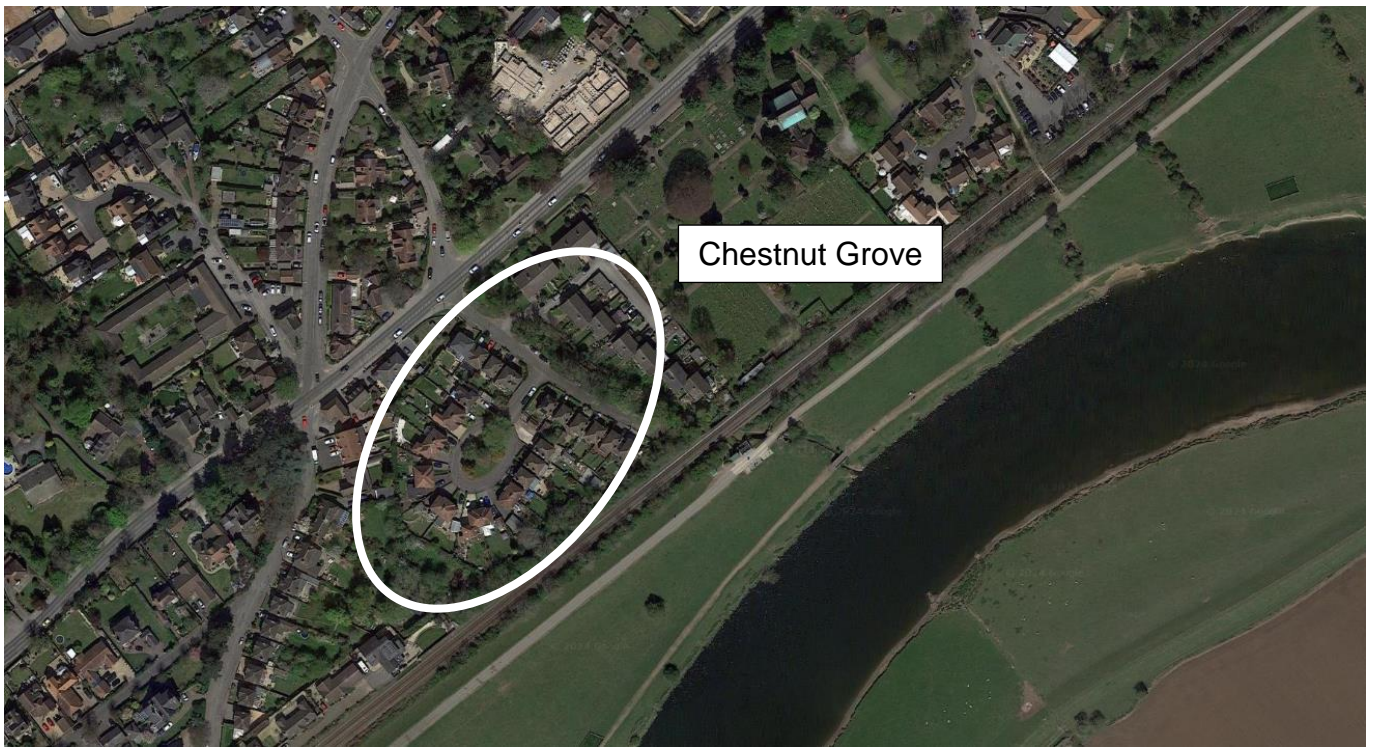
15. Four residential properties suffered internal flooding on Chestnut Grove (Figure 6) due to surcharging of the sewer system. Investigations by STW into the causes of sewer flooding in this area are still ongoing at the time of writing (May 2024).

*Figure 6. View of Chestnut Grove.*
