# Nottinghamshire County Council

# APPENDIX C

# **SECTION 19 REPORT – COLWICK – STORM HENK, JANUARY 2024**

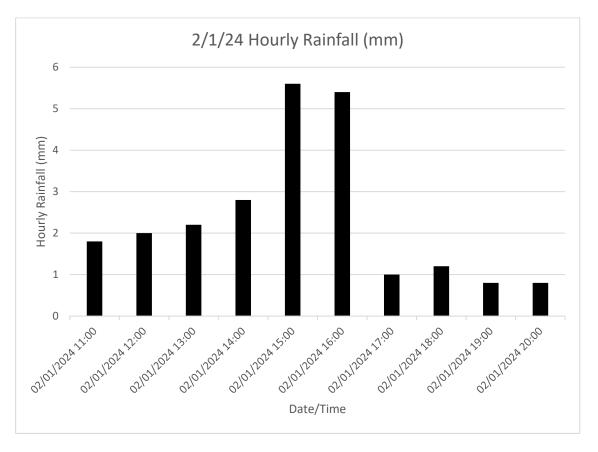
- 8. Between the 2<sup>nd</sup> and 4<sup>th</sup> of January, Colwick suffered a flood event caused by sustained rainfall over a saturated catchment which caused water levels within the River Trent at Colwick to rise to near-record levels. On the 2<sup>nd</sup> of January, 23.6mm of rainfall was recorded at the Colwick rain gauge (Figure 1) with a maximum 60-minute intensity of 5.6mm/hr. Consequently, 16 residential properties and 5 businesses were subject to internal flooding with more suffering flooding to gardens and outbuildings.
- 9. This storm came after a prolonged period of persistent rain and above average rainfall which had saturated the ground, resulting in high river flows and consequent flooding of roads and properties.

Figure 1. Colwick Hourly Rainfall 2<sup>nd</sup> January 2024. Data supplied by the Environment Agency.

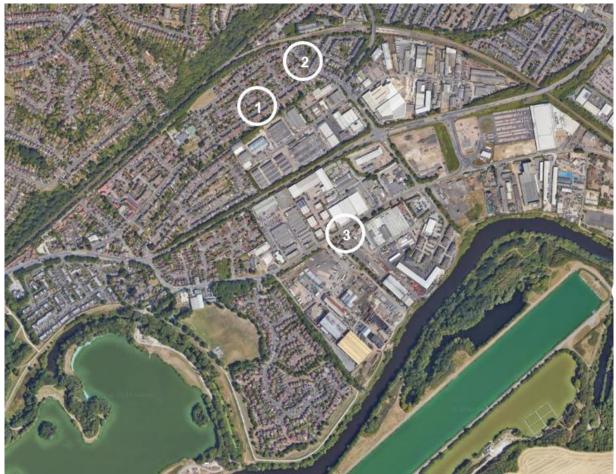
- 10. A location map of Colwick is shown in Figure 2. The areas affected were:
  - Vale Road (15 properties)
  - Charworth Road (1 property)
  - Churchill Business Park (5 properties)

*Figure 2.* Reference Map for flood affected areas across Colwick. Vale Road (1), Charworth Road (2), Churchill Business Park (3).

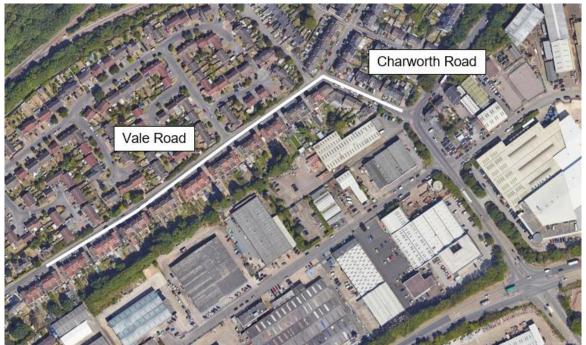
- 11. Areas impacted by flooding on Vale Road and Charworth Road are shown in Figure 3. A watercourse is present which flows from the north-west side of Vale Road before flowing through a culvert under Vale Road and the Business Park to the south. The watercourse discharges to the River Trent via a control structure at the eastern corner of the Business park. Due to the high water levels of the River Trent as a result of rainfall during Storm Henk, and despite over pumping at the control structure site downstream, water from this watercourse was not able to discharge into the River Trent at a sufficient volume and so areas of Vale Road and Charworth Road were flooded as water levels built up within the watercourse. This caused internal flooding to 16 residential properties. It has been stated by residents that vehicles traveling though flood water and causing bow waves exacerbated the flooding to some properties. It was also reported by the Colwick Parish Council that the reach of watercourse closest to the River Trent had a significant amount of litter within it (including large items) which may have reduced conveyance in the channel.

- 12. Affected residents reported that in some instances, water entered properties from below floorboards which indicates groundwater flooding was present. It was also reported by residents that some properties were pumping water out of their premises and into highway gullies. However, a link between pumping out of properties and flooding within the area has not been established at present.

Figure 3. View of Vale Road and Charworth Road.

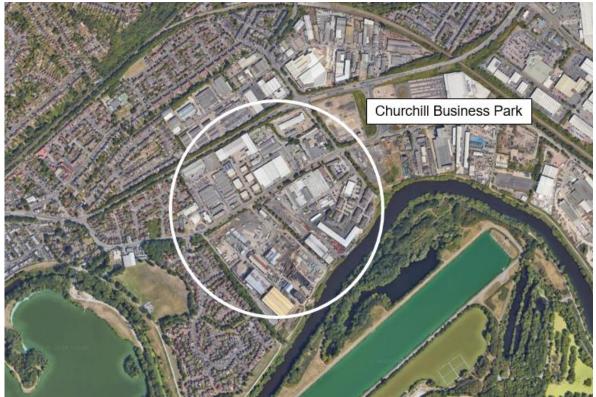
13. Within Churchill Business Park, 5 business properties were internally flooded during Storm Henk (Figure 4). Flooding within the business park was result of the same flooding mechanism as on Vale Road as discussed previously. Water which was not able to discharge from the watercourse into the River Trent caused the water level to rise to a level where the channel capacity was exceeded and so areas of the Business Park were subjected to flooding. However, a second watercourse exists at the southwest boundary of the Business Park. This may have also contributed to flooding in the area through a similar mechanism of high-water levels in the River Trent causing a lack of discharge into it from the watercourse and therefore raised water levels within the watercourse.

Figure 4. View of Main Street.
